APPLICATION STORIES

Customer: A Japanese auto maker

Machinery Involved: O'Bara, Degensha Welding guns.
Equalizing Bar Slides

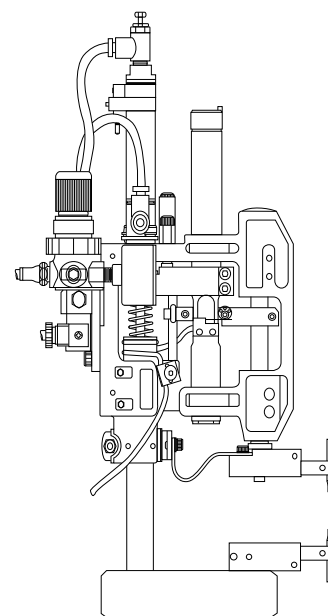
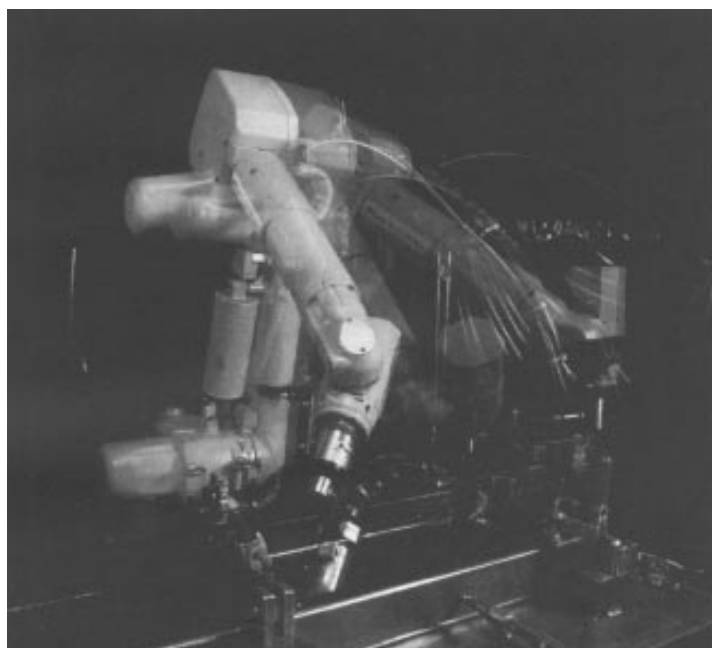
Description of Problem: Welding dust & spatter cause linear ball bearings in the equalizing bar slides to fail within weeks. Downtime was unacceptable.

Solution: Simplicity Japanese Metric Bearings were created and installed without seals or lubrication.

Simplicity Part Used: FJ 16, FJ 20
