# APPLICATION STORIES

Customer: A Japanese auto maker

Machinery Involved: O'Bara, Degensha Welding guns.  
Equalizing Bar Slides

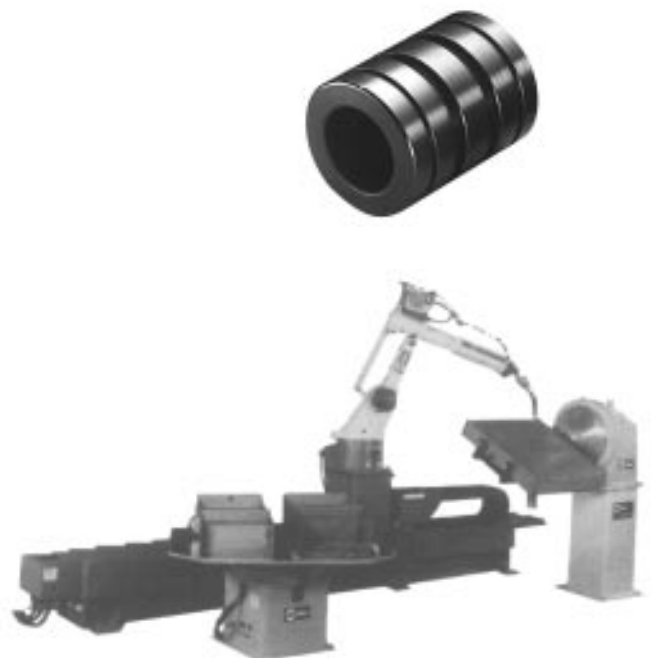
Description of Problem: Welding dust & spatter cause linear ball bearings in the equalizing bar slides to fail within weeks. Downtime was unacceptable.

Solution: Simplicity Japanese Metric Bearings were created and installed without seals or lubrication.

Customer Reaction to Solution: Downtime was eliminated, production was increased.
