# APPLICATION STORIES

**Customer:** A manufacturer of picnic coolers & ice chests

**Simplicity Part Used:** DDS-24

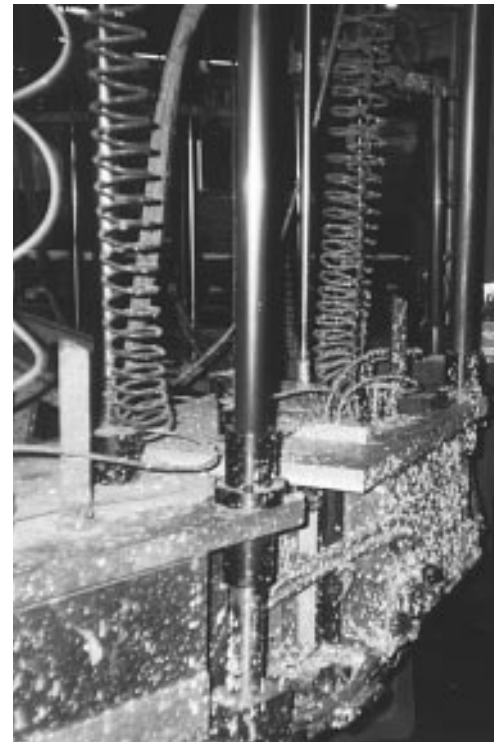
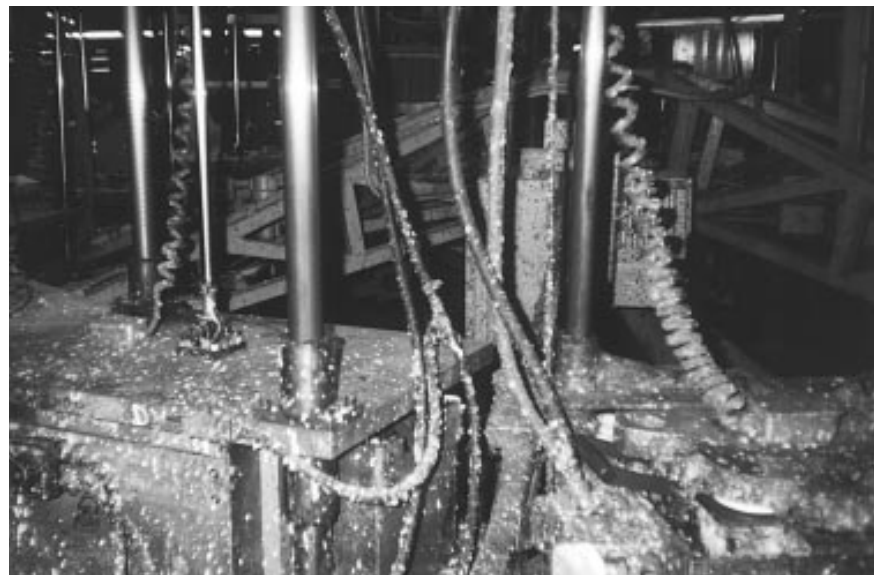
**Machinery Involved:** 2 post hydraulic press, 2" round shafting in the foam area of the plant.

**Description of Problem:** Bronze bearings would fail every 6 weeks due to contamination, loss of lubrication. Bearings and shafting would fail.

**Solution:** Bronze bearings were replaced with DDS 24, modified to accept FL 32 bearing.

**Customer Reaction to Solution:** DDS has been working for 2 years without incident or downtime. Customer is pleased to produce and ship this seasonal product on time.
