APPLICATION STORIES

Customer: A manufacturer of picnic coolers & ice chests

Simplicity Part Used: DDS-24

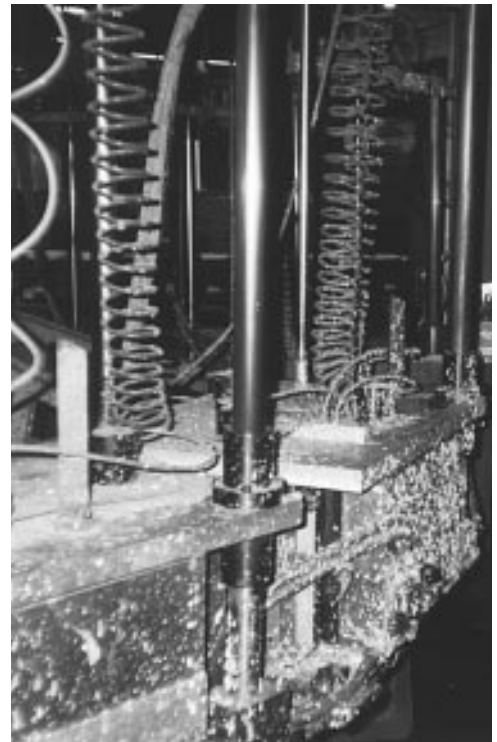
Machinery Involved: 2 post hydraulic press, 2" round shafting in the foam area of the plant.

Description of Environment: 24 hour continuous operation, severe contamination from overspray of insulating foam, high salt content in the air causes corrosion.

Description of Problem: Bronze bearings would fail every 6 weeks due to contamination, loss of lubrication. Bearings and shafting would fail.

Solution: Bronze bearings were replaced with DDS 24, modified to accept FL 32 bearing.

Customer Reaction to Solution: DDS has been working for 2 years without incident or downtime. Customer is pleased to produce and ship this seasonal product on time.
