# NEWS RELEASE

## Carpet Manufacturer Cuts 95% of Scrap Losses with Simplicity Self-lubricating Bearing Solution

Rockford, IL – March 8, 2010

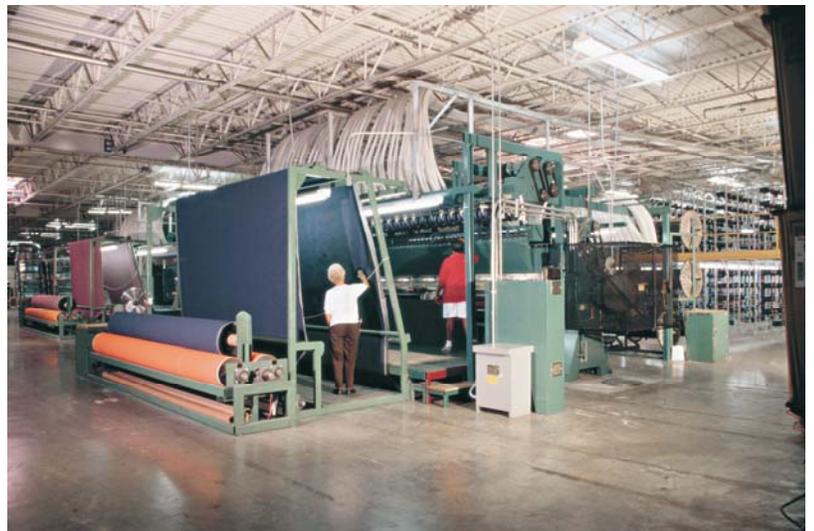
Each carpet tufting machine uses 36 ball bushing bearings and steel shafting assembled into a pushdown foot system (4 bearings and 2 rods of steel shafting per pushdown foot, an average of 9 pushdown feet per machine). This system is utilized within the application to operate the needle bar in quick, reciprocating up to 1600

*Carpet tufting system.*

cycles/minute short strokes. The needle bar holds 4000 tufting needles that conduct the crucial processing of the fibers. Precise and repeatable linear motion is necessary for optimum manufacturing and the minimization of scrap. The manufacturer also employs non-stain oil along the pushdown foot assembly to ensure smooth linear motion and reduced friction.
